FINAL PROJECT REPORT
AGREEMENT # P1796020

*Reclaiming our Public Lands and Watersheds from the
Environmental Threats of Trespass Cannabis Cultivation*

Dates Covered: January 01, 2018 – September 30, 2020

Integral Ecology Research Center

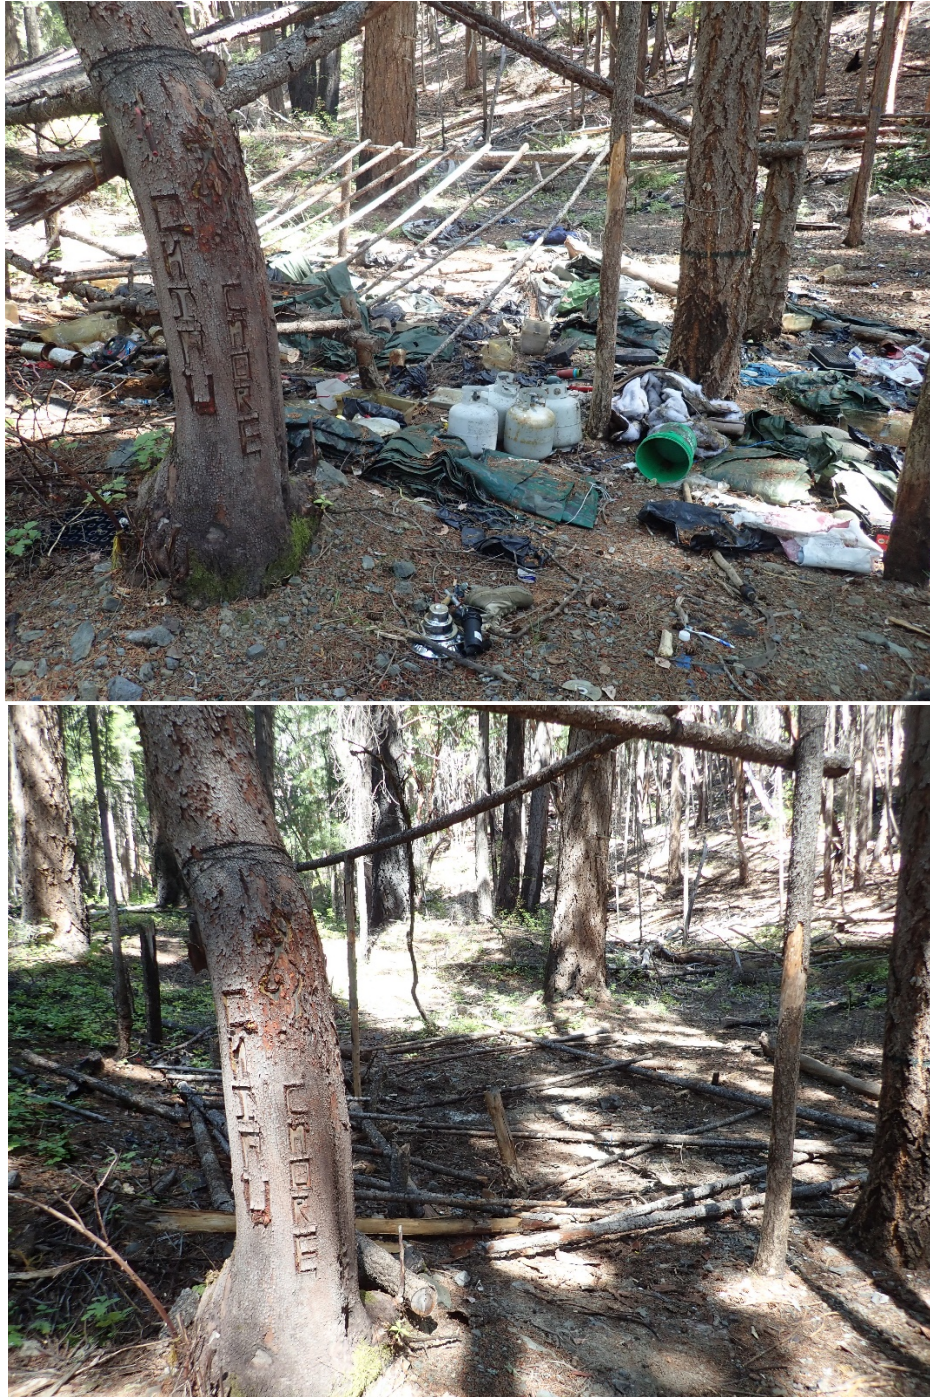
Figure 6. Pre- (top) and post- (bottom) reclamation photographs of a camp at the Big French Wild 2 trespass cannabis cultivation complex reclaimed on August 23, 2019 as a representative example of the 97% refuse removal threshold required to classify a location as reclaimed.

Per Project objectives, TCCS are classified as reclaimed if at least 97% or more of the known refuse and infrastructure is removed. This includes all attractants in the form of food refuse, pesticides, fertilizers, as well as, all water diversion and storage structures including source diversions, cistern and water irrigation piping. Pre- and post-implementation photos were collected at nearly every site; however, only a selection of photos have been presented to visually illustrate site conditions both before and after reclamation activities (Figures 6 – 10).

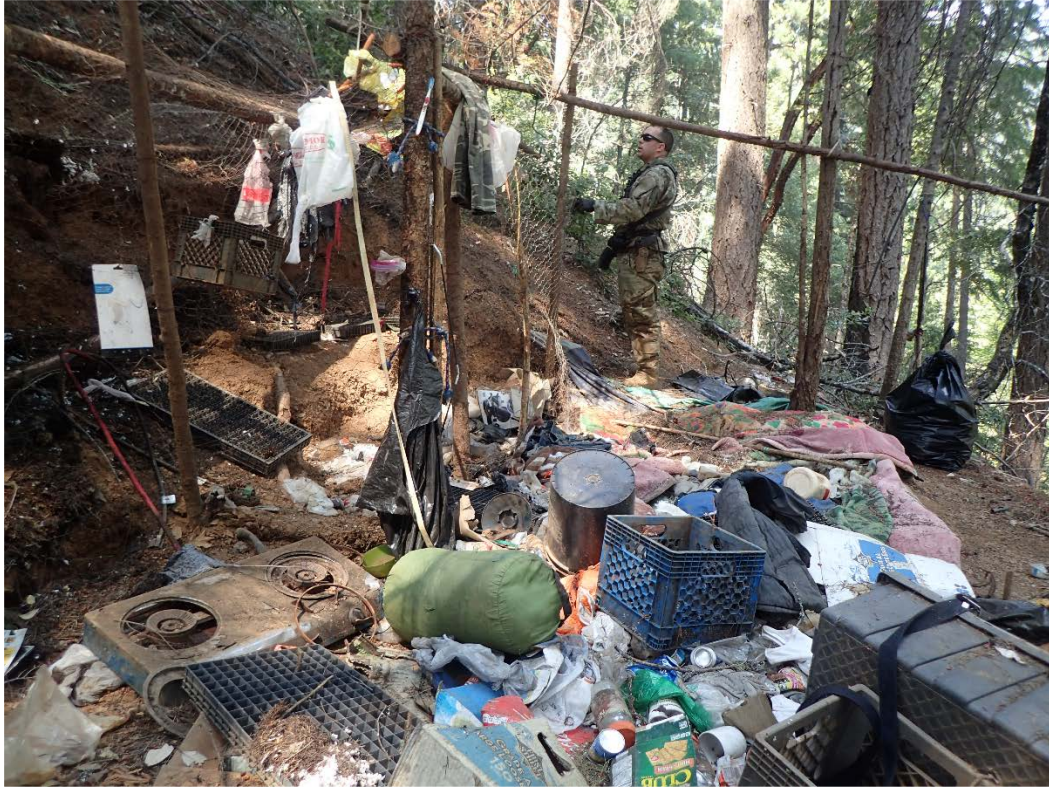
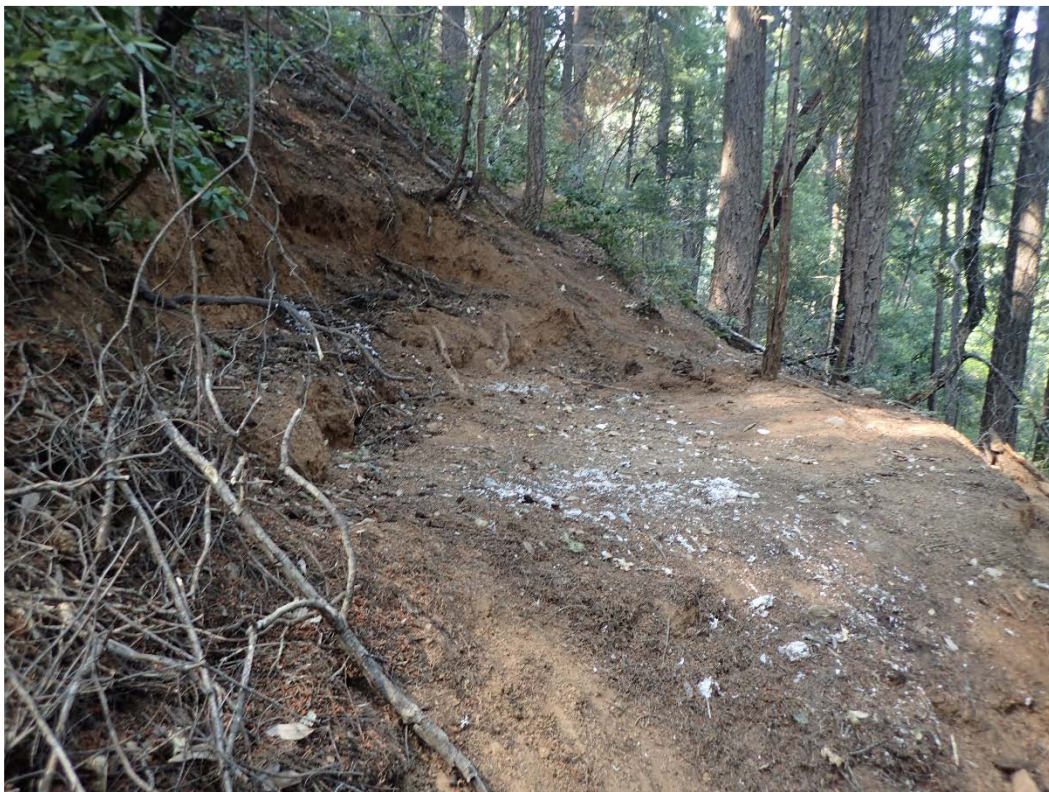
Figure 7. Pre- (top) and post- (bottom) reclamation photographs of a camp at the Big Creek 2 trespass cannabis cultivation complex reclaimed on August 20, 2018, as a representative example of the 97% refuse removal threshold required to classify a location as reclaimed.

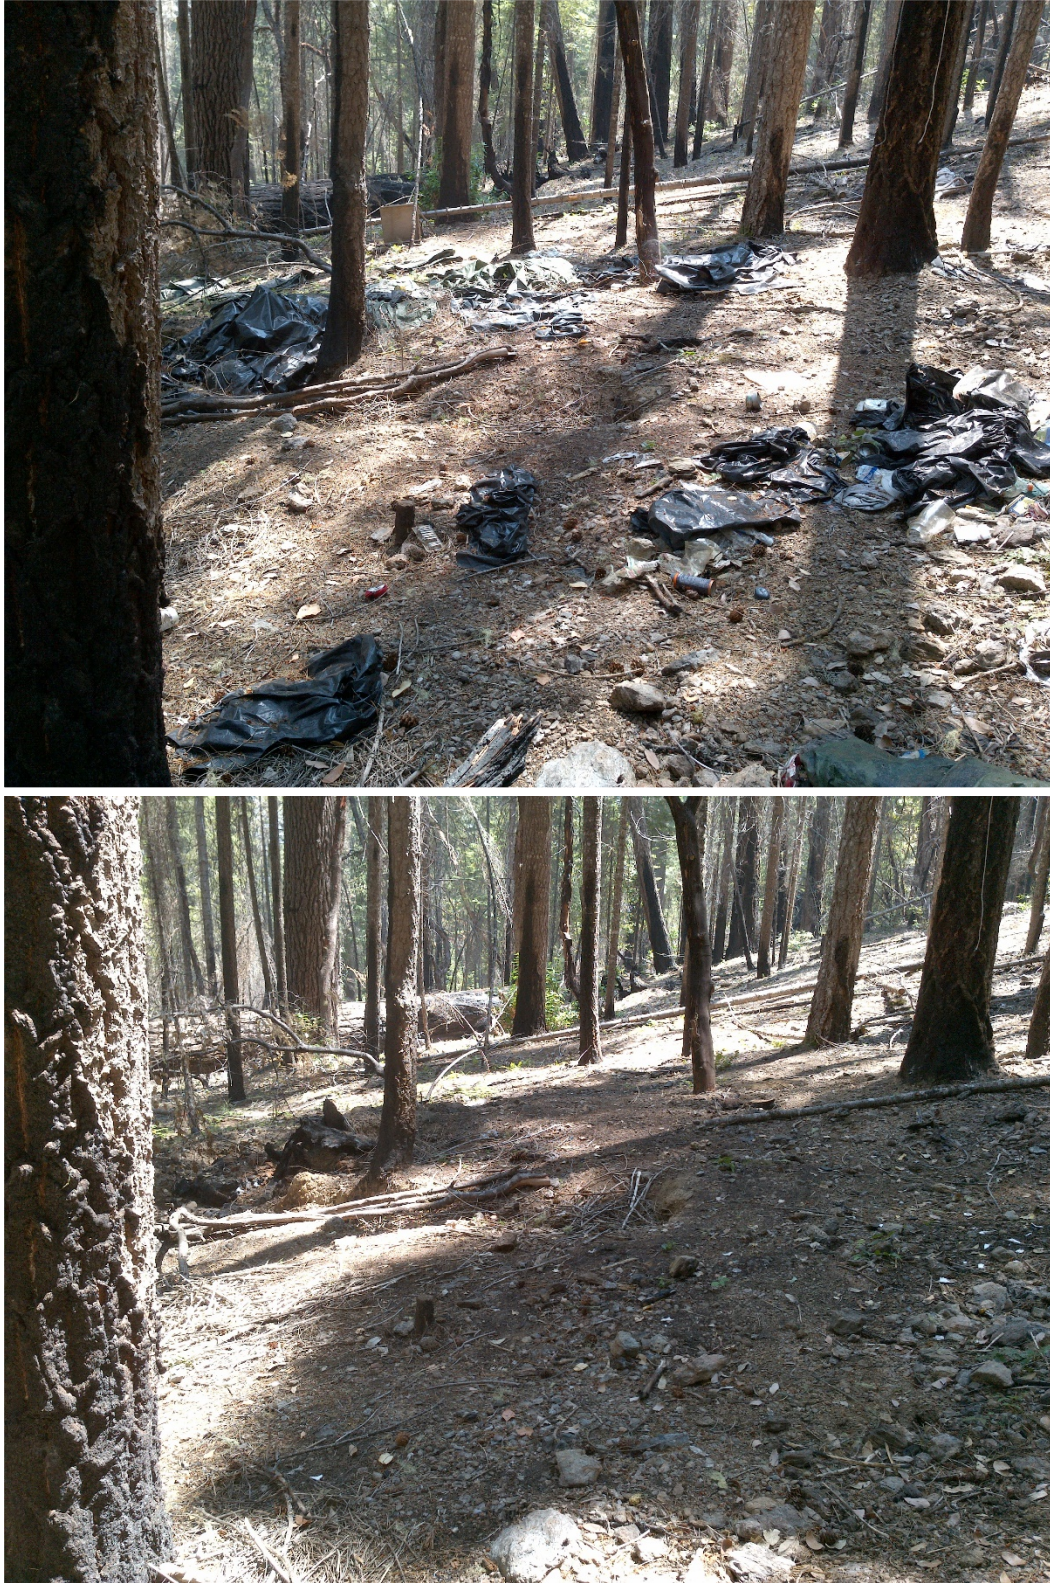
Figure 8. Pre- (top) and post- (bottom) reclamation photographs of a camp at the Eye in the Sky trespass cannabis cultivation complex reclaimed on August 21, 2018, as a representative example of the 97% refuse removal threshold required to classify a location as reclaimed.

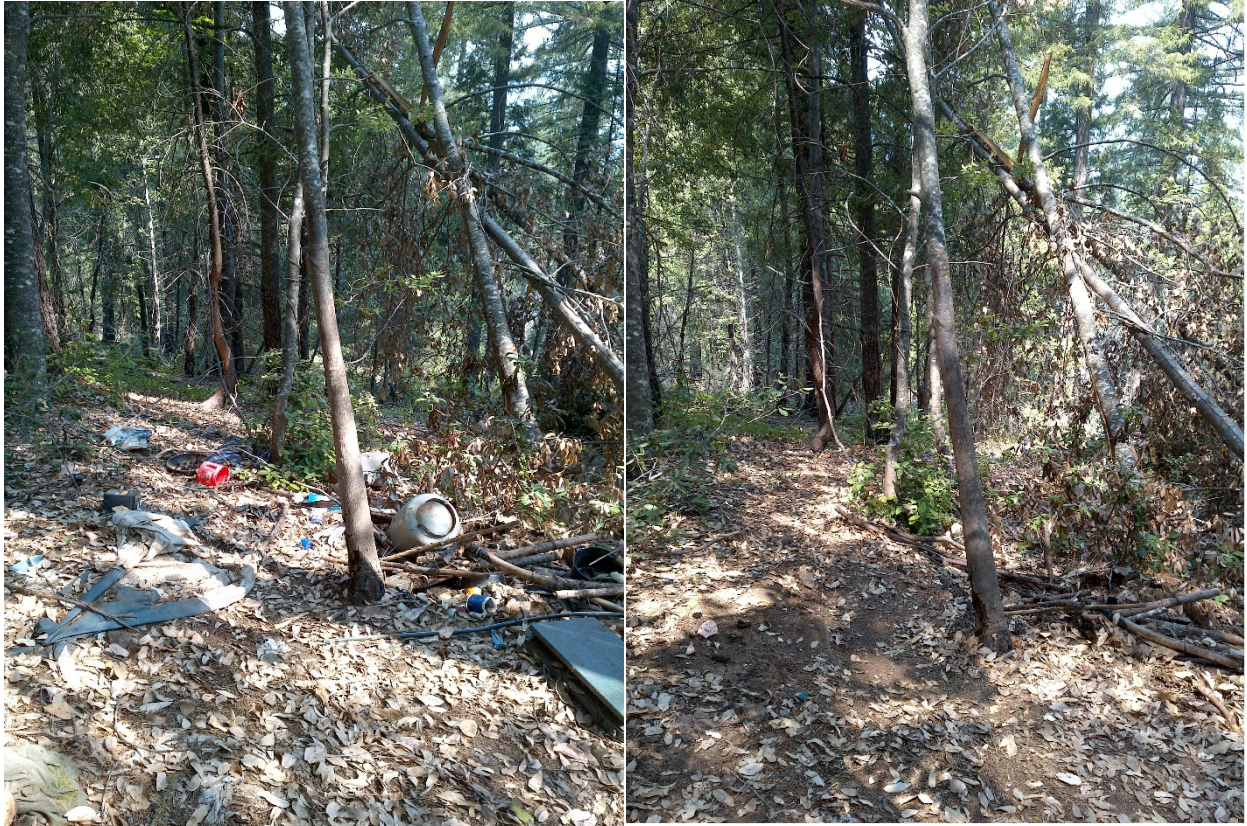
Figure 9. Pre- (left) and post- (right) reclamation photographs of a camp at the Raspberry Delight trespass cannabis cultivation complex reclaimed on July 13, 2018, as a representative example of the 97% refuse removal threshold required to classify a location as reclaimed.

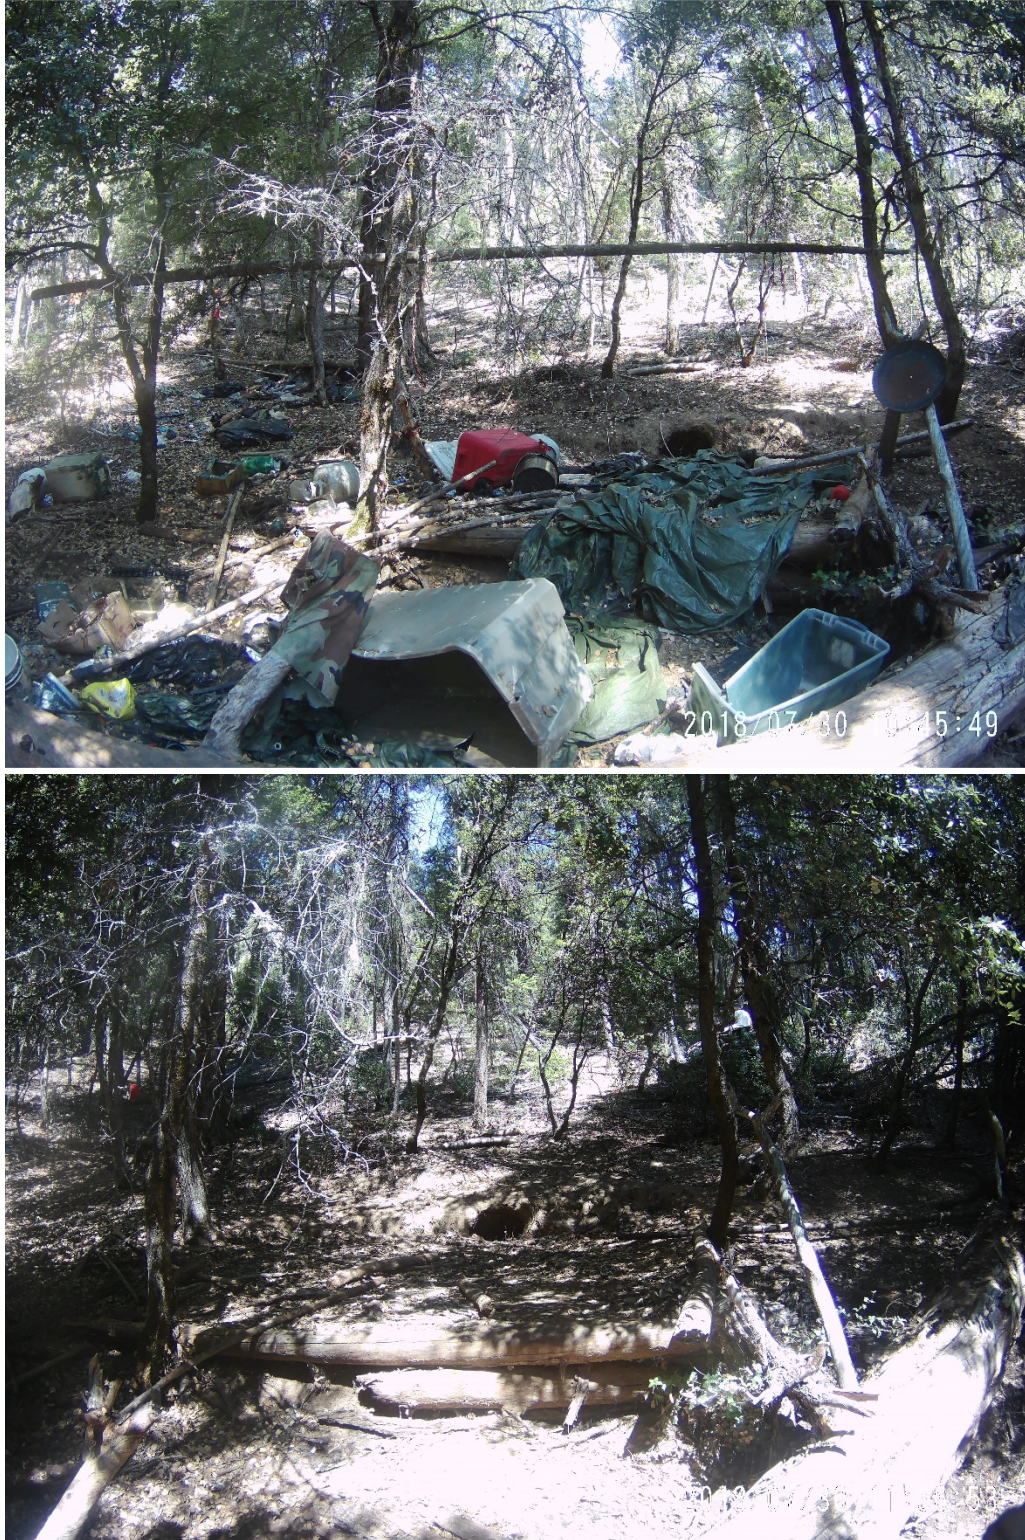
Figure 10. Pre- (top) and post- (bottom) reclamation photographs of a camp at the Wildwood China Gulch trespass cannabis cultivation complex reclaimed on October 25, 2018, as a representative example of the 97% refuse removal threshold required to classify a location as reclaimed.

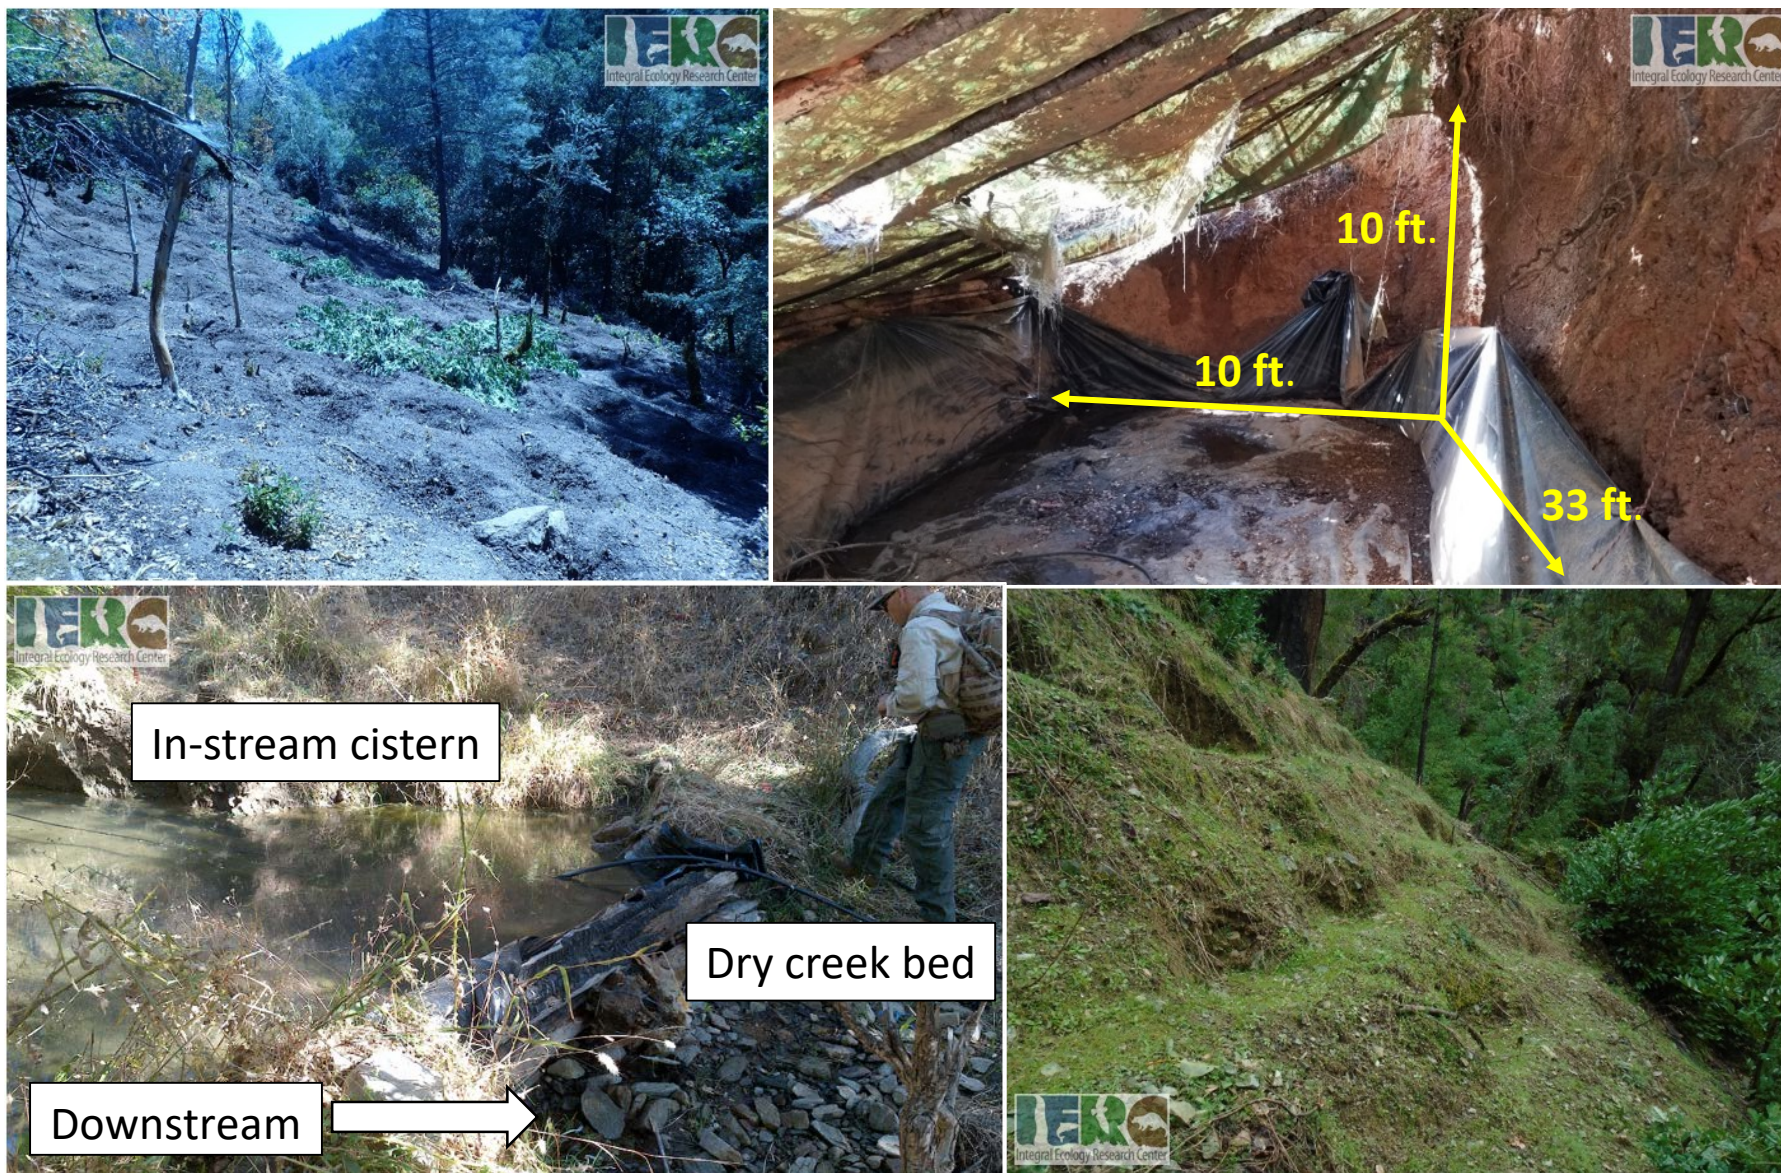
Figure 12. Representative examples of various environmental impacts warranting active restoration efforts, including direct habitat destruction and tree removal (top left), large upland dugout cisterns (top right), in-stream cisterns (bottom left), and earthworks and terracing (bottom right).

Priority	Management Area	TCCC	Impacts	Recommended Restoration
1	Shasta-Trinity National Forest	Plummer Peak	Heavy vegetation clearing; large cisterns both within and outside of creek; heavy application of pesticides	Tree and brush planting, in-stream bank stabilization, soil remediation
2	Shasta-Trinity National Forest	Rays Peak 2019	Heavy vegetation clearing; large cistern	Tree planting with upland fill of cistern; slope stabilization and sediment control
3	Six Rivers National Forest	5 Mile	Heavy vegetation clearing; plot terracing; large cistern; dugout springs	Tree and brush planting; upland bank stabilization; spring restoration
4	Shasta-Trinity National Forest	Wildwood China Gulch	Dugout springs and in-stream cisterns	In-stream bank stabilization and spring restoration
5	Shasta-Trinity National Forest	Raccoon Face 2019	Heavy vegetation clearing; large dugout in-stream cistern	In-stream bank stabilization and tree planting

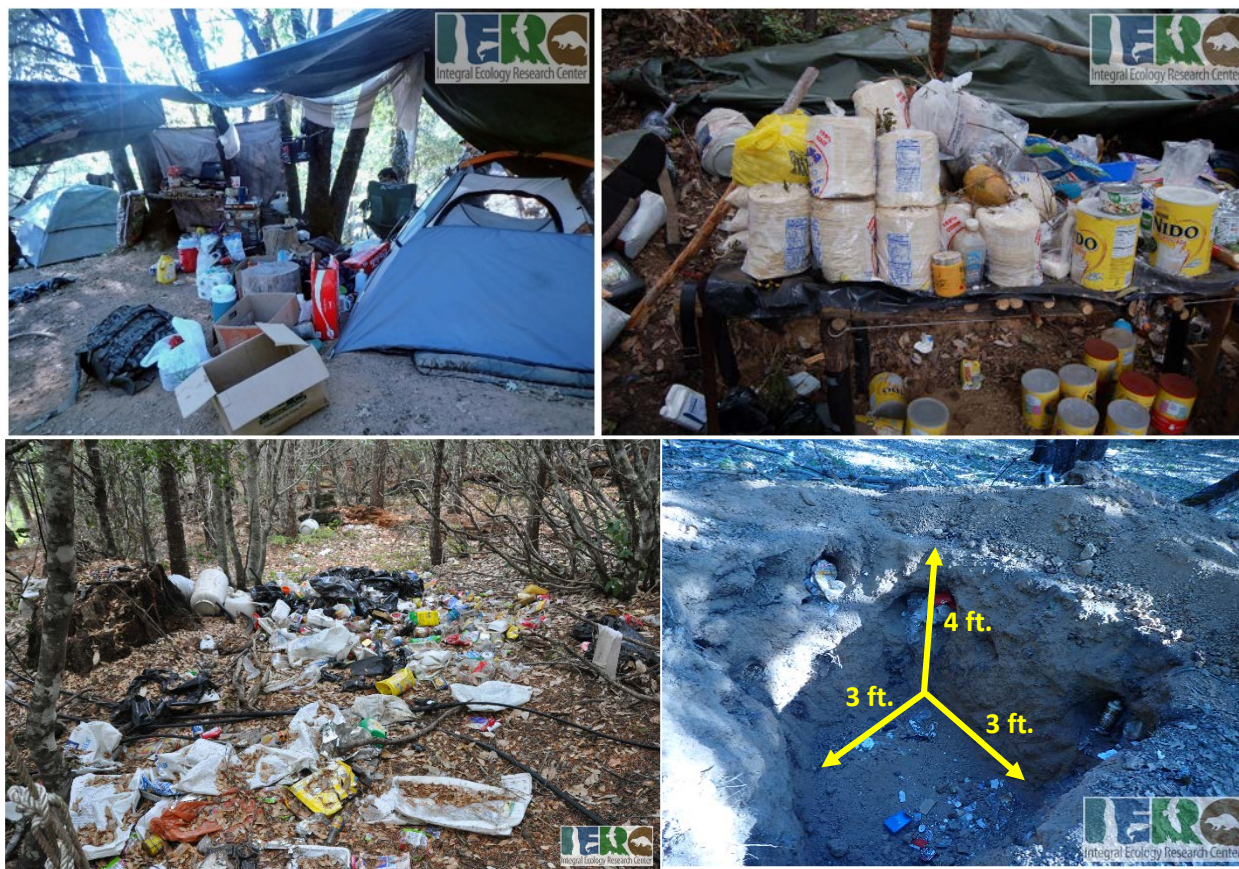
Figure 13. Photo of living quarters (top left) including kitchen and sleeping area indicating long-term on-site TCCC habitation and a close-up (top right) of approximately 130 pounds of fresh food items. Photo of food waste and refuse scattered about the forest floor (bottom left). Photo of an empty freshly dug trash pit (bottom right).

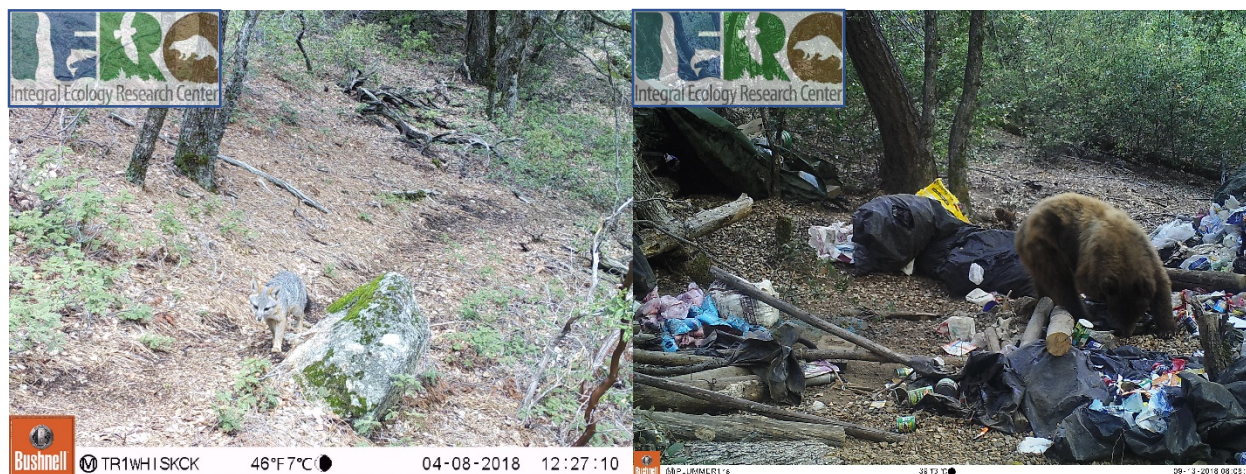
Figure 14. Photo (left) captured by a passive infrared (PIR) motion-activated game camera of a gray fox utilizing a trail established by cultivators en route to a trespass cannabis cultivation complex (TCCC) camp. PIR photo (right) of a black bear rummaging through trash at a TCCC camp.

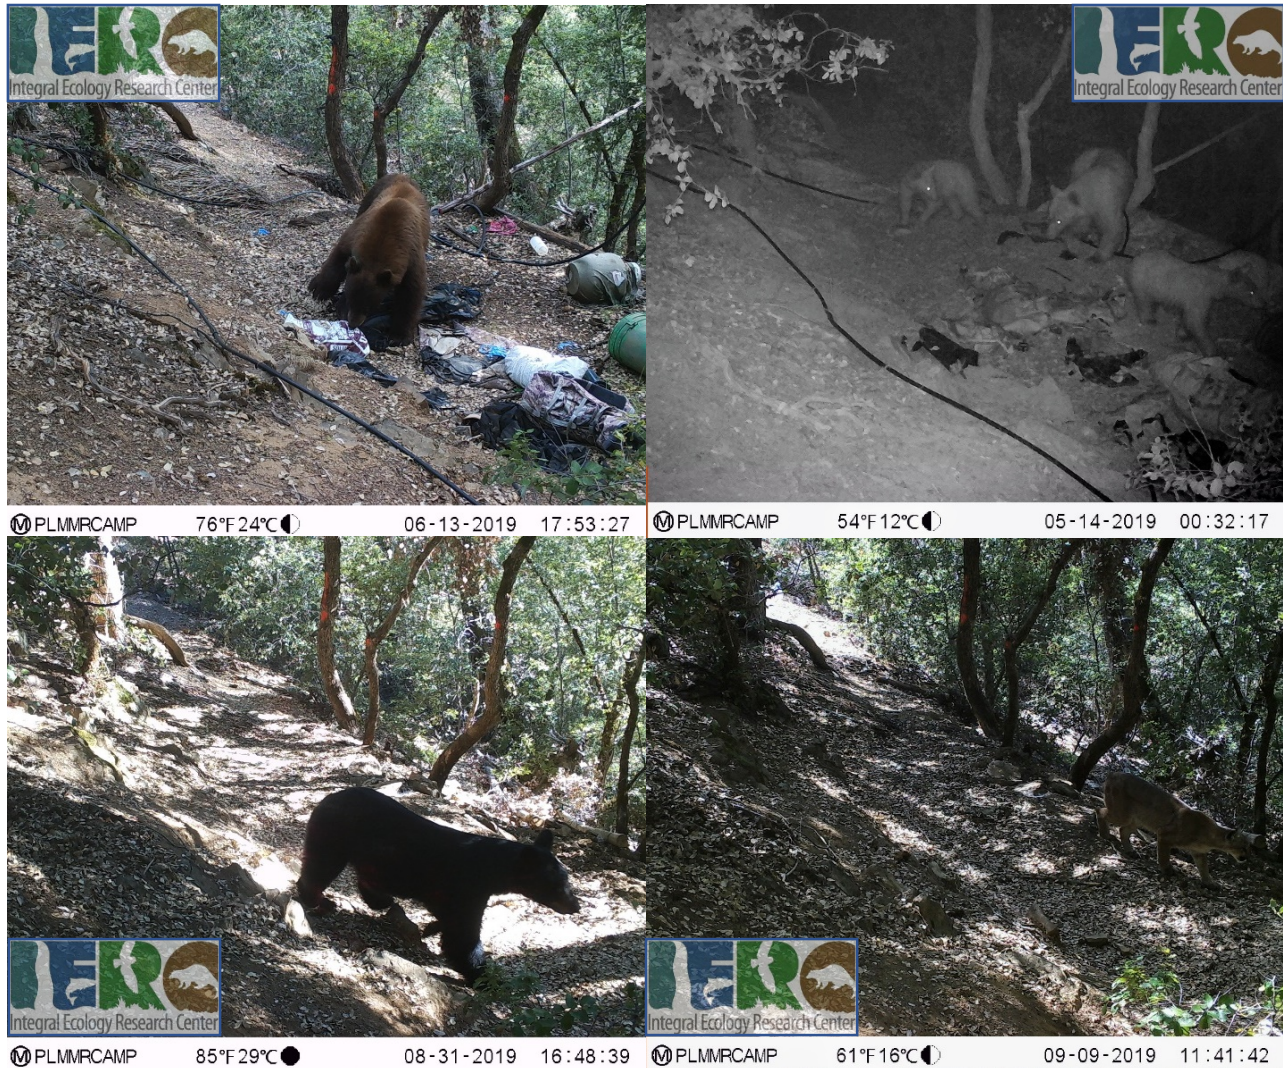
Figure 15. Pre-reclamation photos of a black bear (top left) and cubs (top right) rummaging through refuse and fertilizers at the camp of a trespass cannabis cultivation complex (TCCC). Photo of a black bear (bottom left) and mountain lion (bottom right) returning to the same TCCC camp now lacking refuse and human attractants following reclamation implementation. Notice the individuals simply walking through as there are no readily available food sources.

Reclamation efforts implemented through the Project removed 102,720 lbs. of assorted refuse and food waste from public lands to help reduce TCCC habituation and negative effects on downstream aquatic habitats. Camera trap data indicate that wildlife preference for TCCC continues following reclamation efforts as individuals search for remnant food scraps, but, in the absence of refuse, the individuals are forced to pass through in search of other resources (Figure 15).

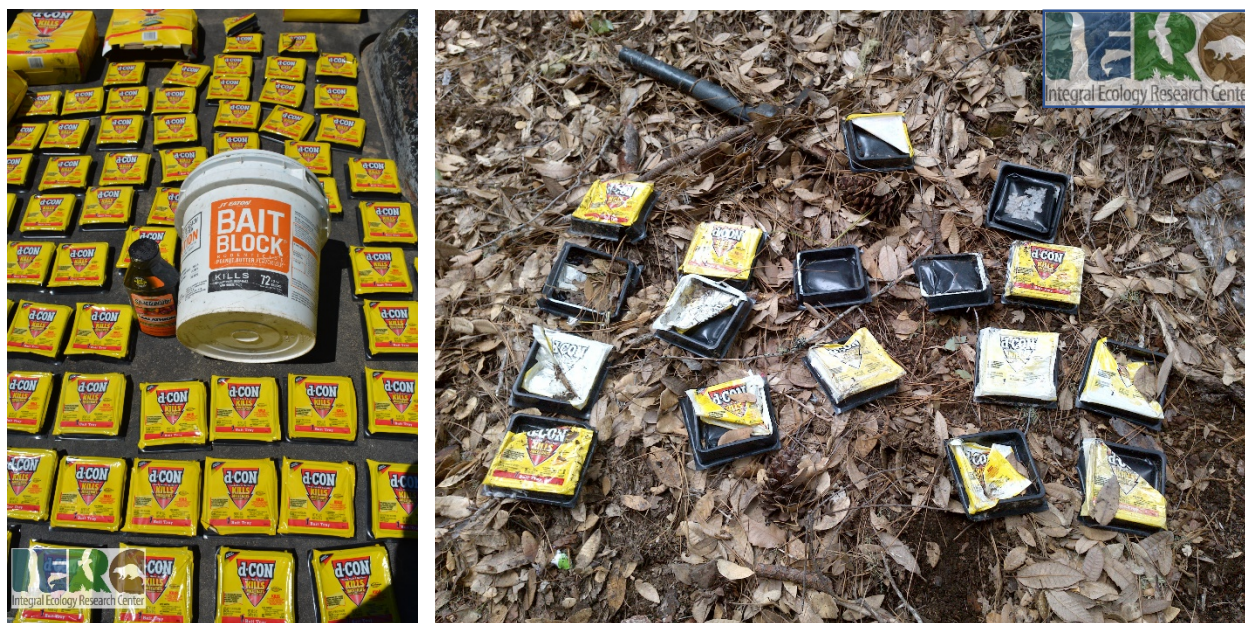
Figure 16. Examples of anticoagulant rodenticide discovered within reclaimed trespass cannabis cultivation complexes (TCCC).

Throughout the Project, AR were discovered and removed or mitigated at 26 TCCCs, in addition of other rodenticides of interest from 21 TCCC. The removal of these substances from the natural landscapes will help reduce wildlife exposures capable of bioaccumulation through the food web. In a continued effort to assess the threat of AR to wildlife populations, IERC's ongoing monitoring projects include a continuation of AR screening of fisher and barred owl populations in the Project Area in collaboration with Hoopa Tribal Forestry.

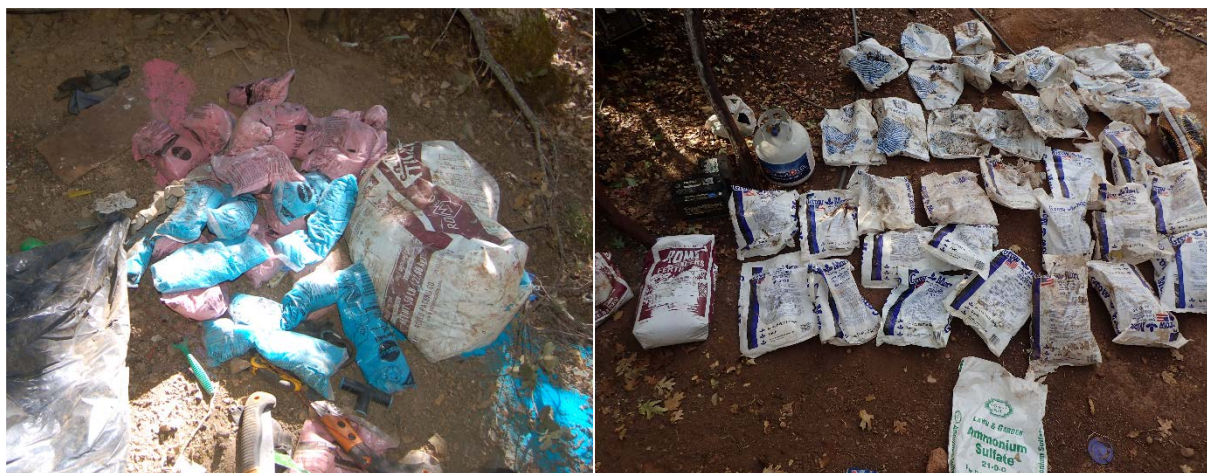
Figure 17. Representative photographs showing the high volumes of concentrated fertilizers detected at trespass cannabis cultivation complexes.

Through the Project assessments, evidence of pesticides and fertilizers were found at nearly every assessed TCCC and 1,050 lbs. of concentrated pesticides, and 83,444 lbs. of concentrated fertilizer were discovered, removed, or mitigated from reclaimed TCCC. In an ongoing cooperative agreement with USFS-LEI, IERC continues to monitor the ever-changing trends in cultivation practices within TCCC.

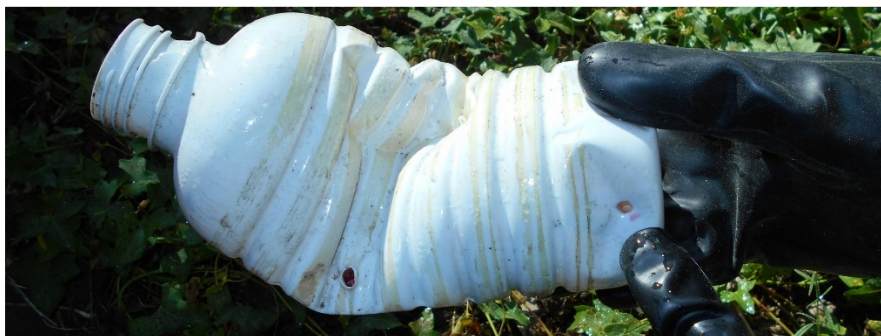
Figure 18. Photograph of an empty container of methamidophos, a highly toxic, banned organophosphate pesticide with holes likely created by a black bear.

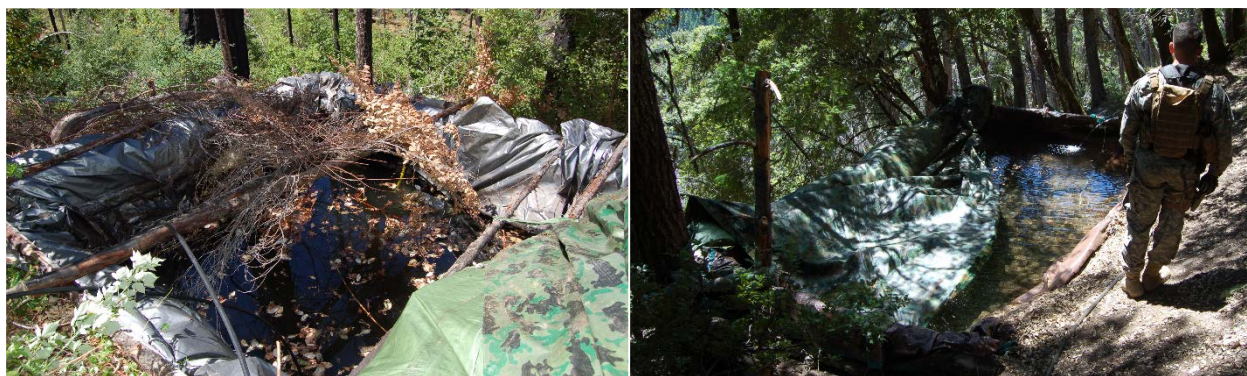
Figure 19. Two examples of lined cisterns capable of storing 9,116 gallons (left) and 23,698 gallons (right) located at trespass cannabis cultivation complexes within the Trinity Alps Wilderness.

In addition to withdrawing water directly from streams, many TCCC have reservoirs that store water within upland habitats on-site. Reservoirs found at TCCC are variable in size, ranging in storage capacity from 100 to over 30,000 gallons. Through reclamation activities implemented through the Project, 115 upland and in-stream cisterns were detected at 58 TCCC and removed through reclamation activities. These water storage infrastructures were mitigated throughout the entire Project Area within 18 HUC 10 watersheds and 48 HUC12 subwatersheds.

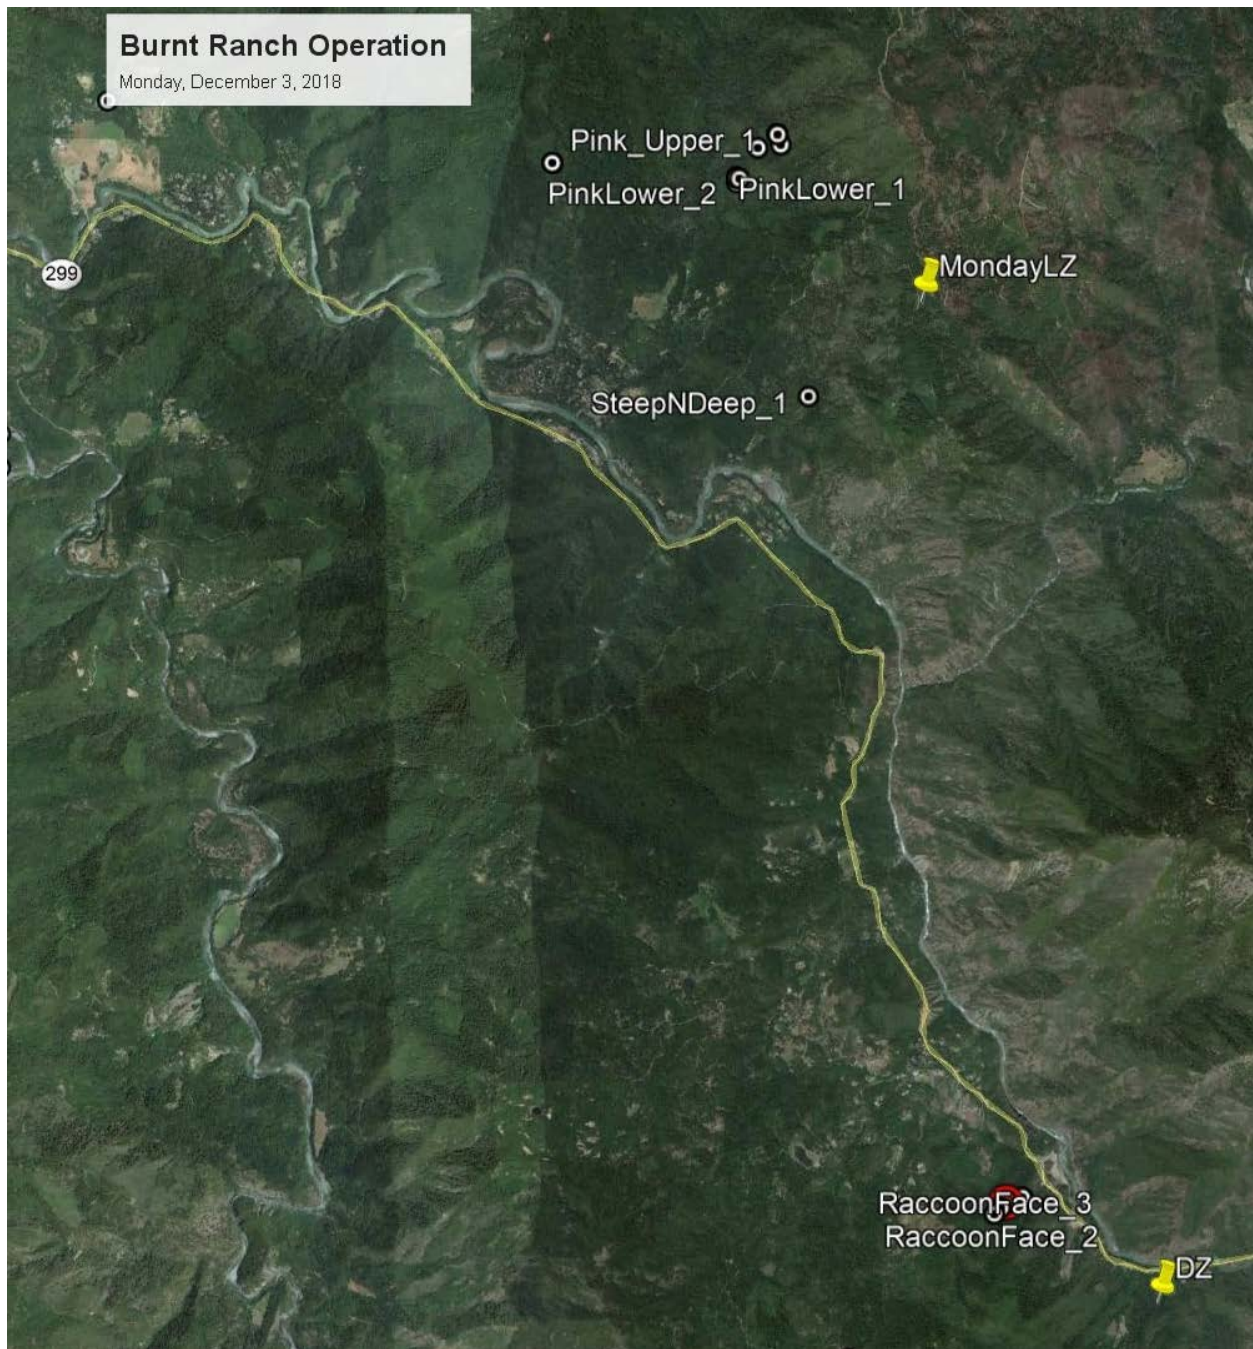
Figure 2. Locations of marijuana cultivation complexes scheduled for reclamation, landing zone and drop zone for operation scheduled for Monday, December 3, 2018.

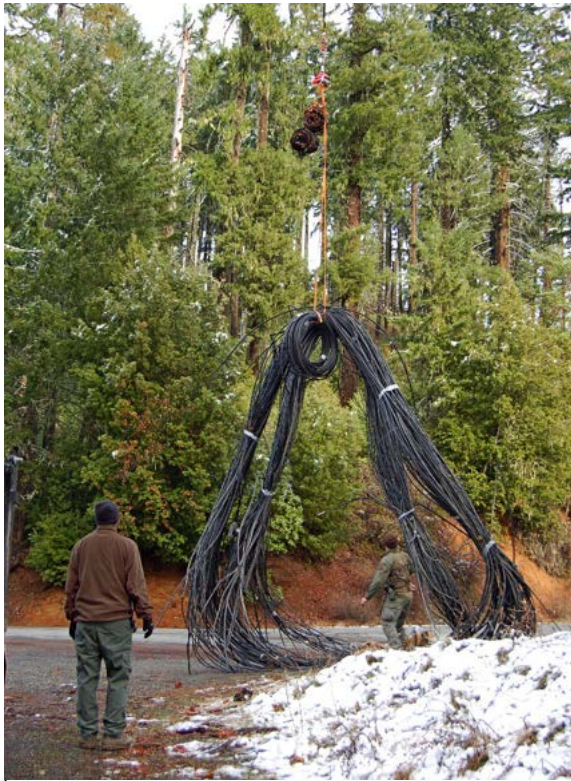
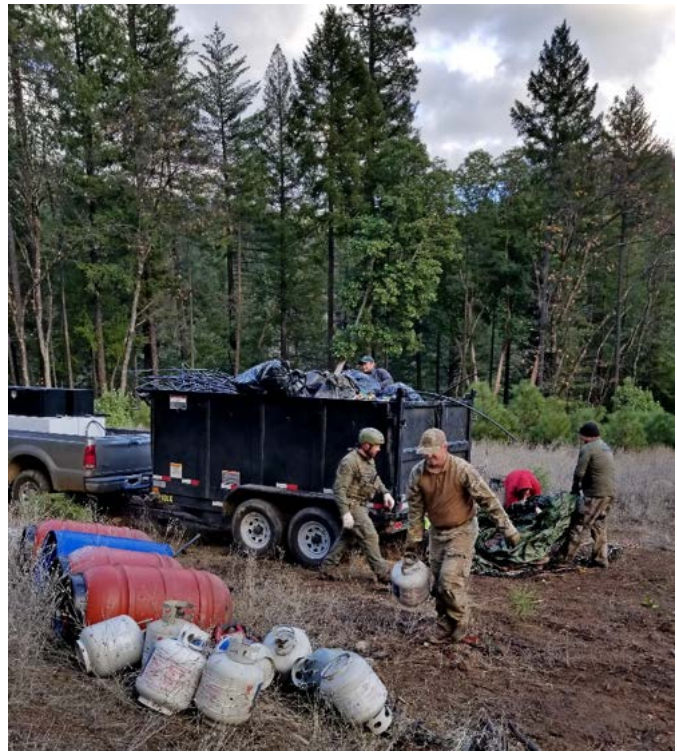
Top Photo Left: One of several irrigation pipe loads, which were diverting streams.
Top Photo Right: Amount of refuse removed from one complex.
Bottom Photo: A delighted team following a successful reclamation operation on National Forest Lands.

Irrigation pipe removed during reclamation: 5.9 miles (31,034 ft)

Long-line loads: 33 loads (Total long-line flight time ~ 6.8 hrs)

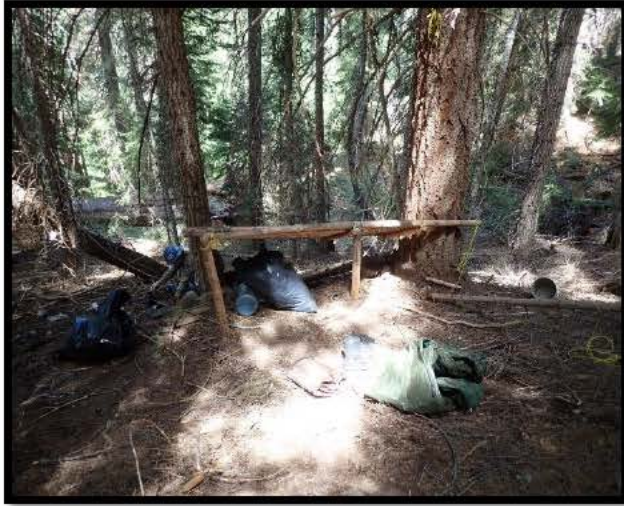
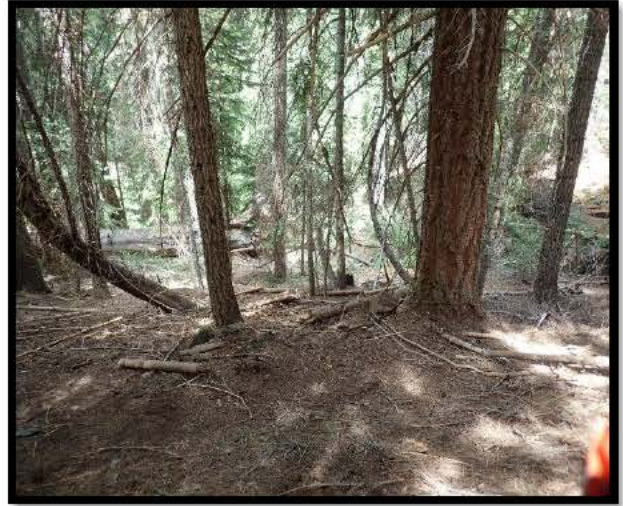
Top Photo: Before and after photos of reclamation within a camp at one of the trespass cannabis cultivation complexes on the Klamath National Forest located in Siskiyou County northeast of Cecilville.

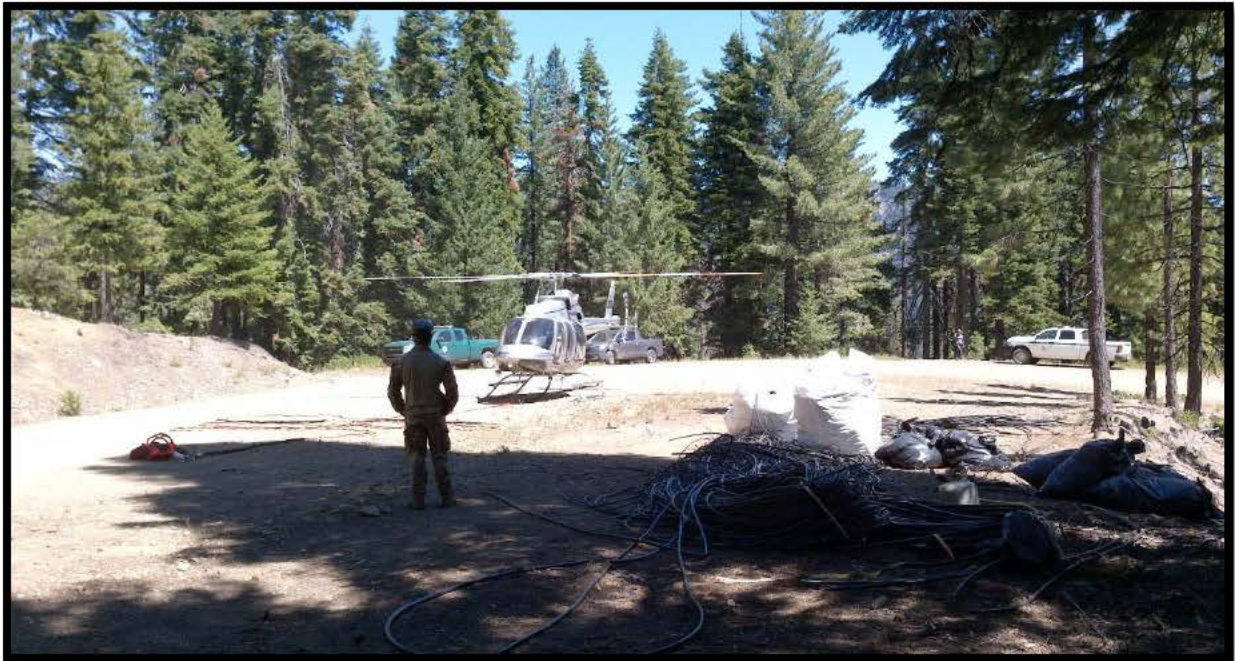
Top Photo: Over 1,400 lbs. of refuse and grow site infrastructure after being removed from two trespass cannabis cultivation complexes on the Klamath National Forest located in Siskiyou County northeast of Cecilville.

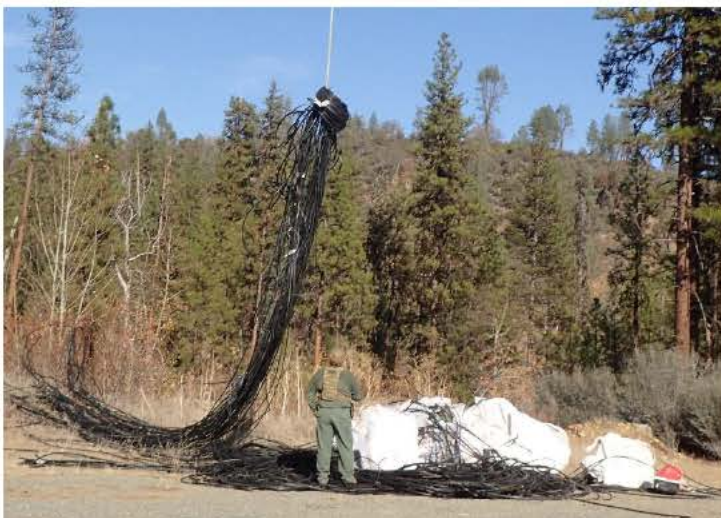
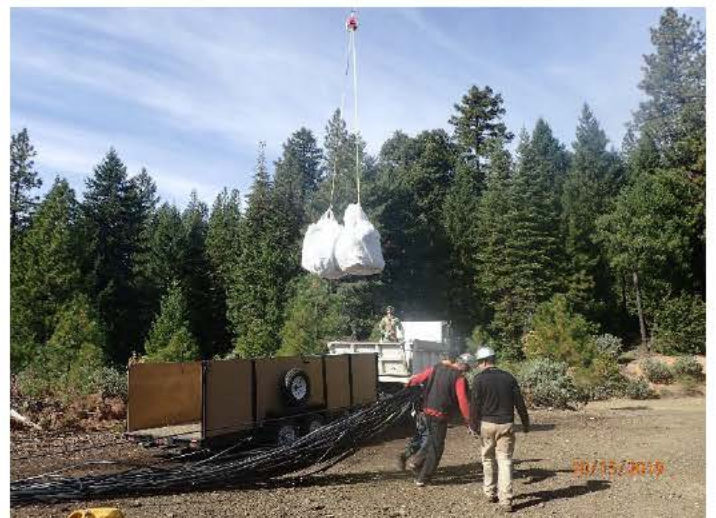
Top Photos: (Left) Members of the California Conservation Corps and (right) the United States Forest Service working to pack and transport refuse for aerial removal on Shasta-Trinity National Forest located in Trinity County southwest of Hayfork.

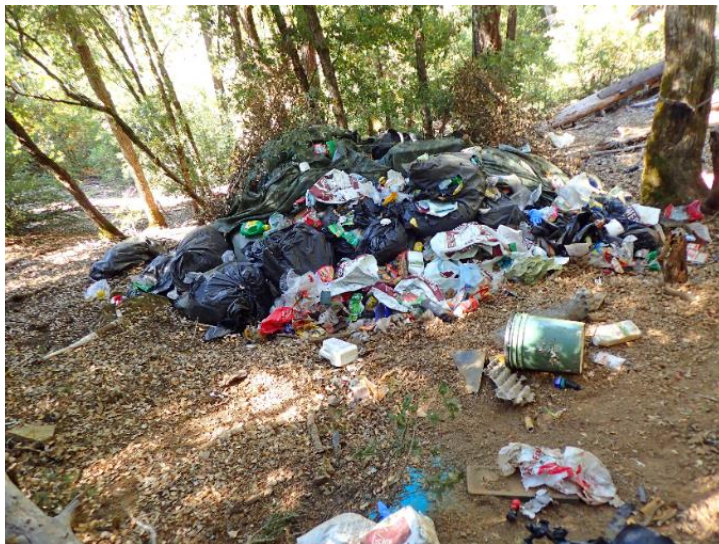
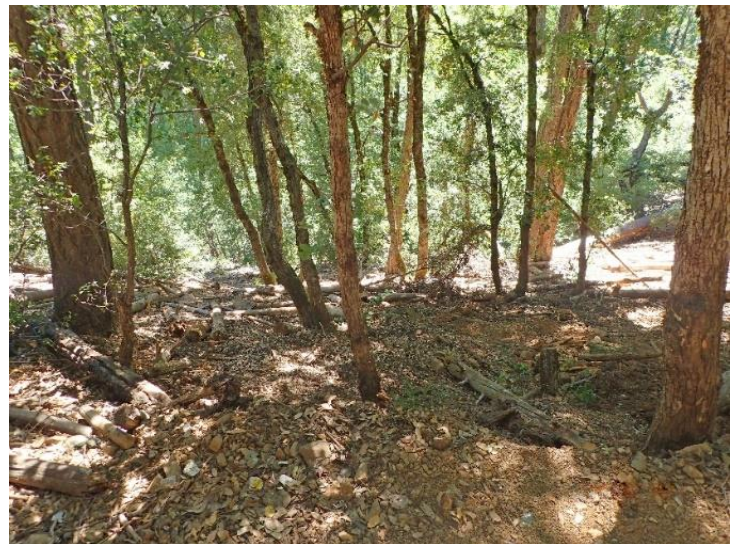
Top Photos: (Left) Before and (right) after photos of reclamation within a camp at one of the nineteen trespass cannabis cultivation complexes on the Shasta-Trinity National Forest.
